EXCAVATIONS IN THE MAMILLAH AREA, JERUSALEM: THE MEDIEVAL FORTIFICATIONS

RONNY REICH AND ELI SHUKRON

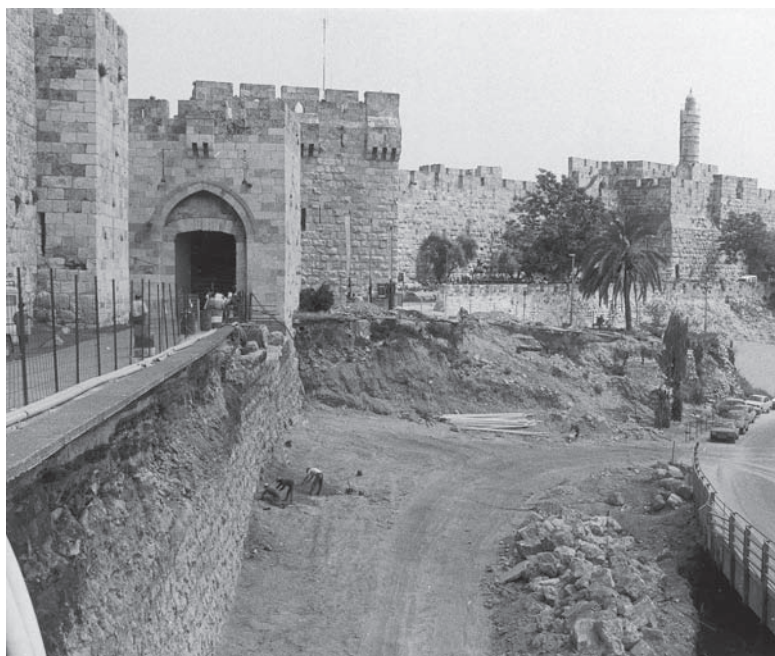
Fig. 3. General view of the Ottoman city wall and the Ayyubid city wall below, looking southwest toward Jaffa Gate.

The remains of this wall run parallel to the present Ottoman wall of the Old City to the west, about 6.25 m from it—or more correctly, the Ottoman wall was built parallel and east of the older wall (Figs. 2, 3; Plan 1).

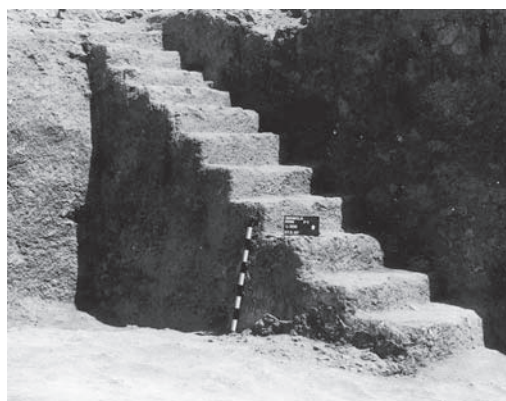
Fig. 5. View of the corner between the Ayyubid wall and its tower, with rock-cut staircase in between, looking north.

A rock-cut staircase descends from the point where the wall and the tower meet to the level rock surface outside it (Figs. 4–7). The staircase is c. 1.15 m wide, with twelve steps having a

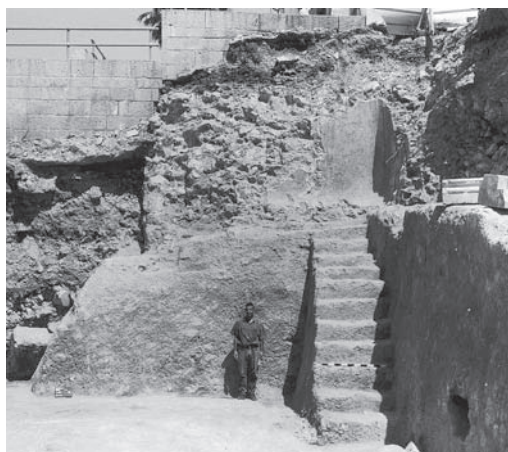
Fig. 4. Rock-cut part of the tower with staircase, looking northwest. On the right, the lower rock-cut part of the Ayyubid wall.

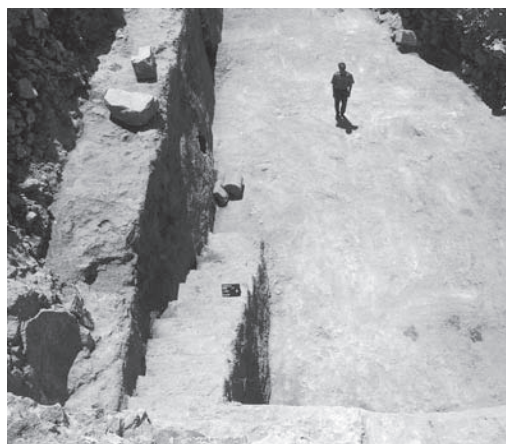
Fig. 6. View from above the rock-cut Ayyubid tower, wall and staircase, looking southeast.

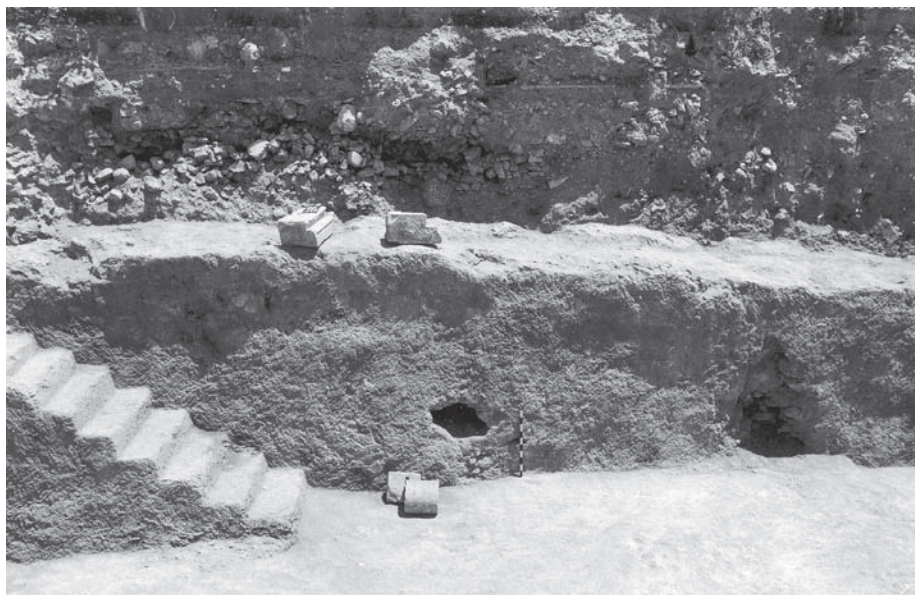
Fig. 7. Rock-cut part of the Ayyubid wall and staircase, and the flat rock space in front of them.

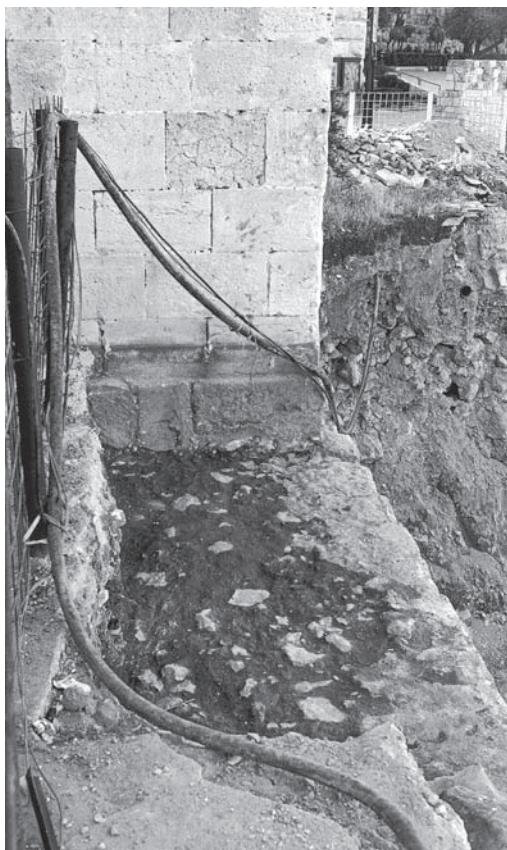
Fig. 8. View of the top of the Ayyubid wall. The face is built of large ashlars with a core of cement and small fieldstones. The base of the Jaffa Gate is built directly over the Ayyubid wall.

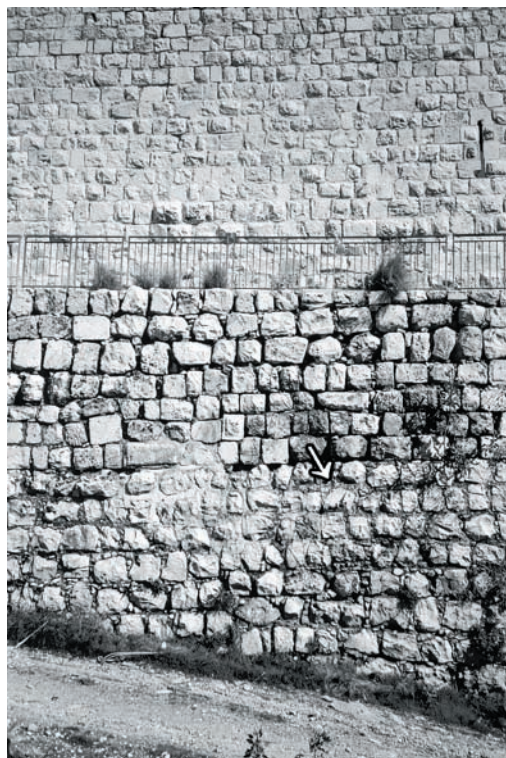
Fig. 9. The Ayyubid city wall. Above the fence is the Ottoman city wall, looking northeast; A decorated springer of an arch is incorporated in the wall (marked with an arrow).

The wall was built of stone blocks, averaging 0.5×0.5 m, with some of the stones reaching a length of c. 0.7 m (Fig. 9). The stones seem not to have been specifically quarried and cut for this purpose, and apparently the builders collected stones from various places in no particular order. The wall included ashlar from destroyed buildings. Some were nicely dressed, while others included profiled stones from destroyed portals and the like.

1) At 47.0 m, elevation 769.33 m: An incorporated ashlar stone with typical oblique Crusader fine-comb dressing. Here the wall is preserved to elevation 770.21 m (Fig. 9).

4) At 60.0 m to 62.0 m, elevation 765.85 m: Four ashlar, clearly in secondary use, were incorporated in a low stone layer near the current path (Figs. 9, 12), from left to right:

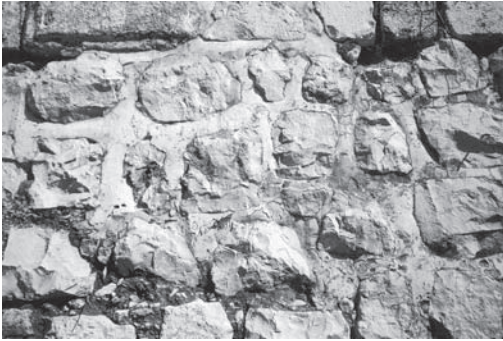
Fig. 10. The Ayyubid city wall, detail of pointing between stones.

2) At 49.0 m to 52.5 m, elevation 768.74 m: The fine pointing between several stones was preserved down to the original ground level (Fig. 10).

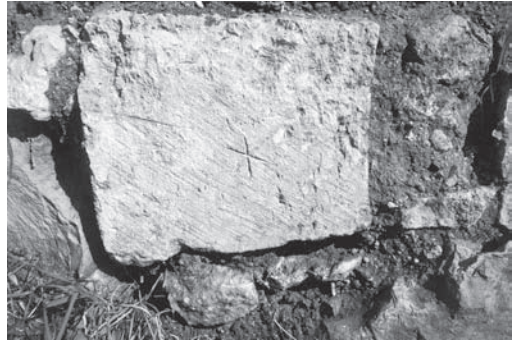
Fig. 13. The Ayyubid city wall: dressed stone bearing a mason's mark.

d) Soft limestone ashlar set one course lower than the other three stones, its face showing fine comb dressing, and bearing an asterisk-like mason's mark (Fig. 13), incised with a sharp instrument.

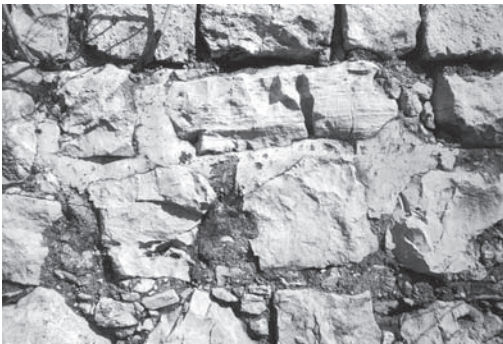
Fig. 11. The Ayyubid city wall, detail of pointing between stones.

3) At 57.5 m to 61.8 m: Another area of fine pointing survived, similar to the previous one, down to the original ground level at elevation 767.50 m (Fig. 11).

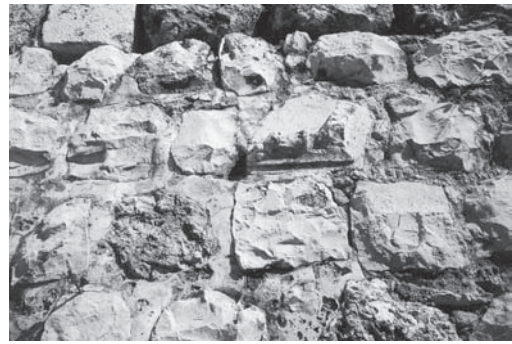
Fig. 14. The Ayyubid city wall, decorated springer of arch incorporated in wall (detail of Fig. 9).

5) At 62 m, elevation 768.50 m: A decorated ashlar set in the seventh course above the current path. The flat faces are dressed with a fine-comb chisel. Originally, the stone served as a springer of an arch, and bears, in relief, the remains of a protruding molding which accompanied the arched opening (Fig. 14). Most of the molding or decoration was damaged. Only part of a four-

From the large stone collapse we secured items of some architectural or artistic significance (Figs. 22–27). Another stone of this group is incorporated in the city wall (Fig. 14). Some

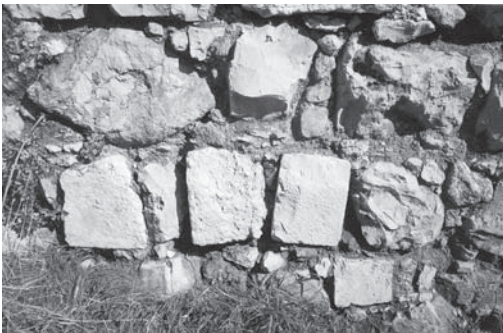
Fig. 12. The Ayyubid city wall; dressed stones incorporated in the wall.

a) Reused roughly dressed ashlar set in the wall with the original face downward.

b) Ashlar set in the wall with its original face on the left into the wall.

c) A hard limestone ashlar, its face worked with a pointed chisel, and the margins on the right and at the bottom carefully cut with a fine, flat chisel.

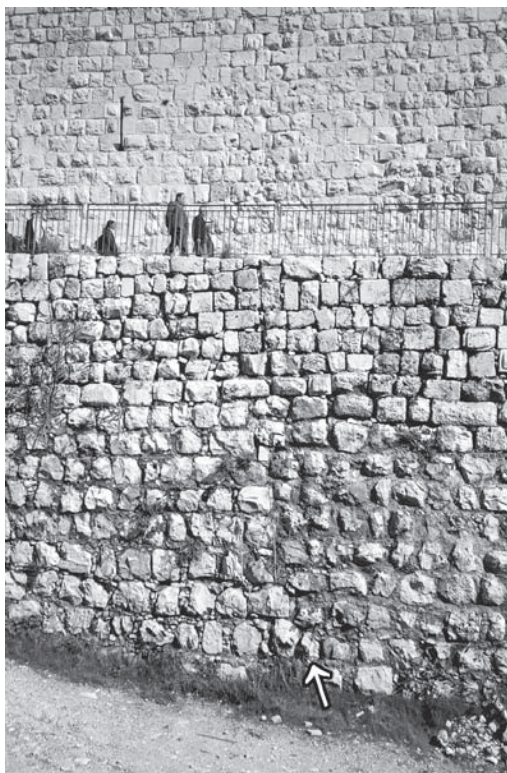
Fig. 15. The Ayyubid city wall, slanting 'seam' (marked with an arrow).

6) At 72–73 m from the rock tower: A 'seam' in the wall, along eight stones, which terminated in one line (Fig. 15). The seam was not vertical, as usually is the case in such a feature, but slants from left to right (west to east). The horizontal stone layers, on both sides of the seam, were not aligned. However, the heights of the stone layers, as well as the material used to cement the stones together, were the same. This seam might point to changes in the line of the fortification that were carried out during the process of construction. As the existence of a city gate is anticipated in the vicinity (because of the presence of the Jaffa Gate in the Ottoman city wall which is built above the wall under discussion), probably further to the southeast, such changes in construction are expected.

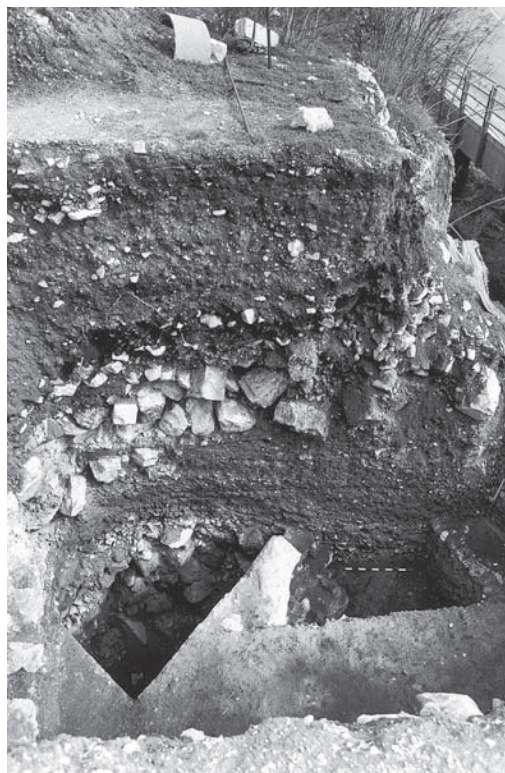
Fig. 16. Probe excavated near the Ayyubid wall northwest of the aqueduct. The stone collapse is covered with the black layer. At the bottom is the upper edge of a Second-Temple-period pool, looking southeast.

An elongated section 4×7 m was cut perpendicular to the face of the wall. At 2.8–3.3 m above bedrock, the entire space was covered with a thick and oily black layer.

Immediately below the black layer, the entire space was covered by a massive stone collapse. Most of the collapse consisted of separate ashlar, but included also a large chunk of destroyed wall of several ashlar still adhering together, at least 2.4 m thick.

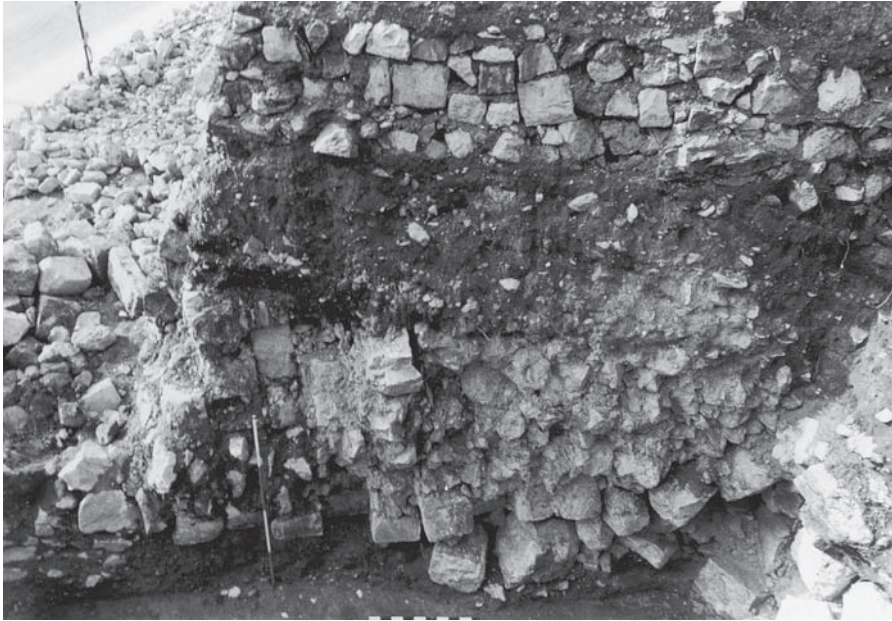
Fig. 17. Same as Fig. 15, looking northwest.

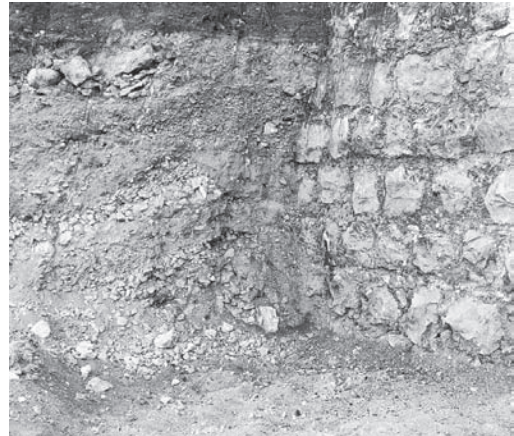
Fig. 18. Foundation trench (L195, L198) of the Ayyubid wall, cutting into the layer of earlier debris.

Here the foundation trench of the wall (L195, L198), which contained gray debris, clearly cut through the brown debris (Fig. 18). At its southwestern side a line of stones was exposed—the kerb of the open space, or path, along the nearby aqueduct. In the bedrock, a corner of a rock-cut plastered pool was filled with a collapse of small ashlars and late Second-Temple-period pottery. The dig was halted at a depth of 3.25 m from the top of the pool.

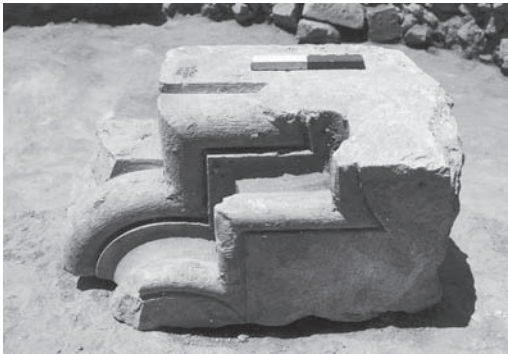
Fig. 25. Base of engaged column.

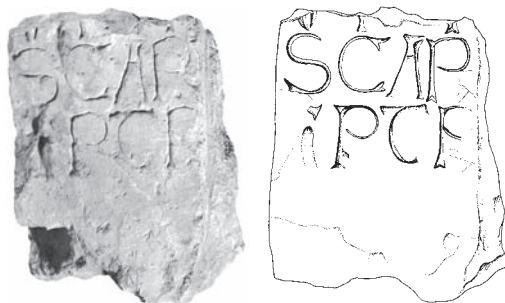
2) Inscribed tombstone (Area F1, Locus 500, Reg. No. 5009) upon a marble slab of which a fragment, 9.5 × 11.0 cm, of its upper left-hand side survived, c. 3 cm thick. The remains of three lines are extant, with letters 1.8–2.0 cm high. The inscription reads:

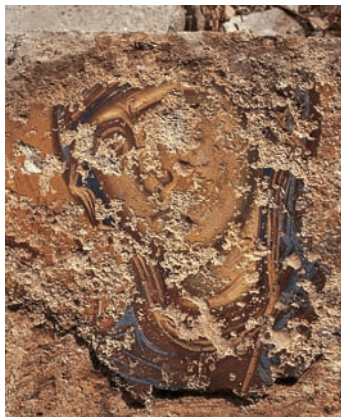
Head of Madonna (Fig. 30).— This patch of plaster, c. 33 × 40 cm, depicts the head of a young Madonna slightly inclined to the left. Since the distance from the edge of the chin to the line of the head covering on the forehead is c. 22 cm, the depiction is clearly larger than lifesize, by 25–30%. The head is on a yellow/ocher background which most probably is part of the halo, although its circular outline did not survive. The woman wears a robe which also covers the head. Her robe is painted in dark brown. Blue coloration (mostly ultramarine and some lighter blues) seems to render the shadows cast by the folds of the robe. The woman's skin is painted in light ocher, in several hues, while the shadows cast by her eye sockets and nose are painted in dark brown and gray.

Considerable parts of the plaster are damaged. Since the left eye of the Madonna is cut out completely, it seems that part of the damage was deliberate and predates the destruction of the edifice and the reuse of its stones.

Fig. 30. Fragment of fresco:
head of Madonna.

Contemporary comparative material from Jerusalem is scant. The best and closest piece is a fragment of a wall painting depicting the head of an angel, found in the excavations in the Garden of Gethsemane (today kept at the Museum of the Flagellation Convent). There seems to be a similarity in the rendering of the facial features. Both faces are quite naturalistic. The Gethsemane angel and our Madonna suggest the work of a highly talented and trained Byzantine artist (Kuehnelt 1991:344–347).

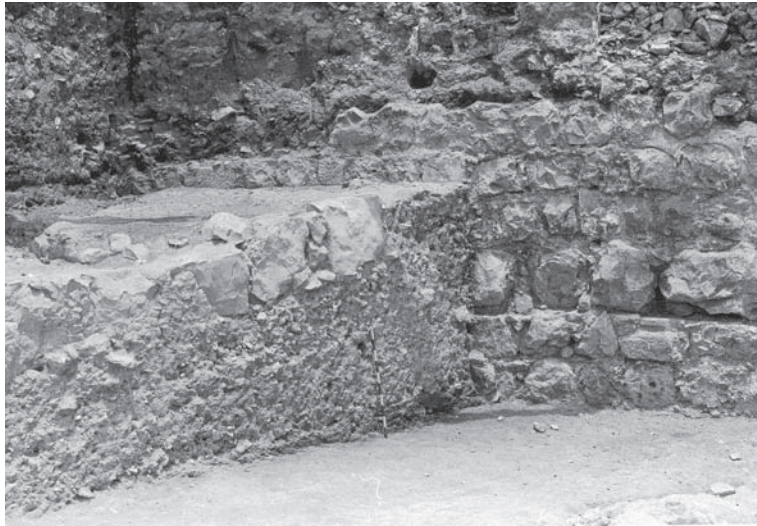
Fig. 31. The Ayyubid wall and its foundation trench (dark debris) cut through walls of Byzantine buildings (at the edge of the area excavated by A. Maeir).

The general medieval date of this line of fortification is certain due to the fact that the wall was constructed directly over the ruins of the Byzantine bathhouse (Figs. 31, 32; Plan 1: Section 5–5). At one place the wall is built over

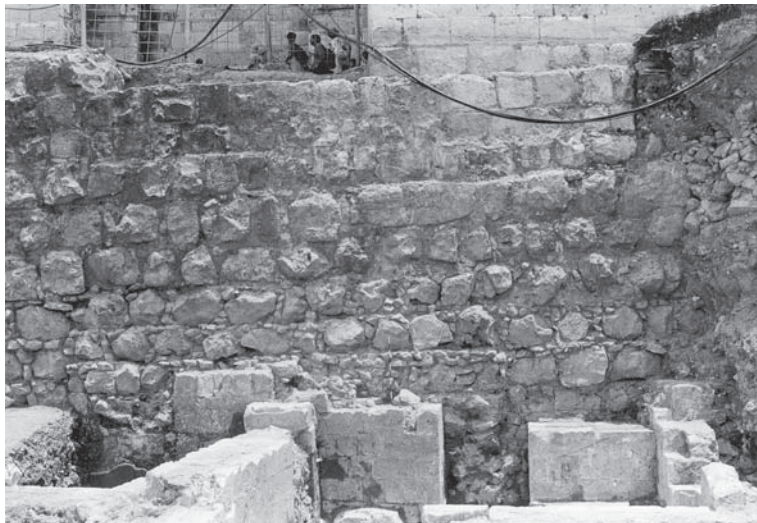
Fig. 32. The Ayyubid wall constructed above the wall with an opening to the Byzantine bathhouse, below the Ottoman Jaffa Gate.

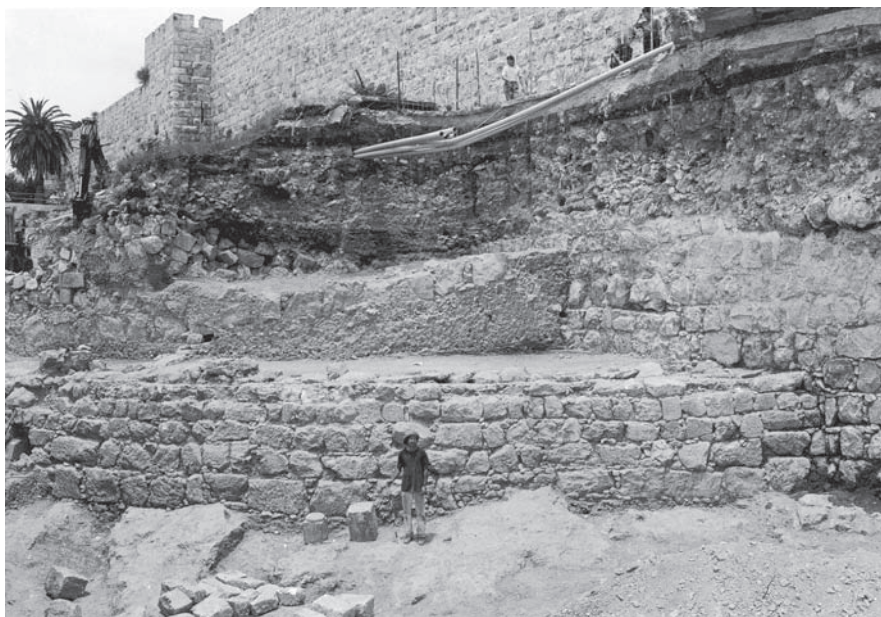
Fig. 33. The aqueduct from the Mamillah Pool.

(actually incorporating in its construction) the Mamillah aqueduct (Figs. 33, 34), which is also dated to the Byzantine period.

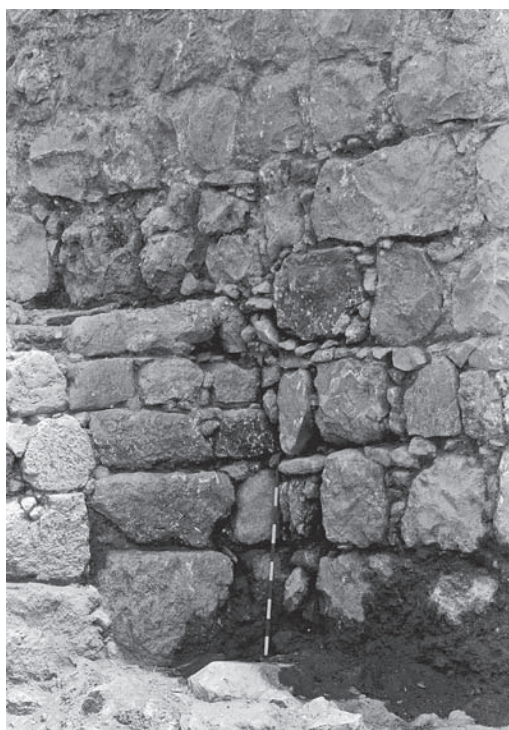
Fig. 34. The aqueduct from the Mamillah Pool, at the point where it is incorporated in the Ayyubid wall (detail).

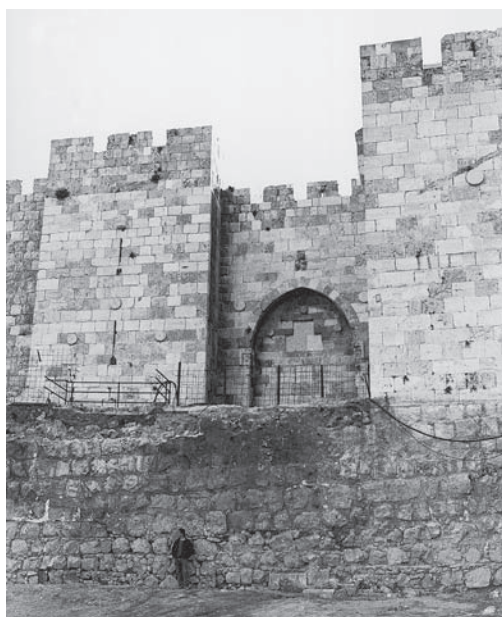
Fig. 35. Jaffa Gate, constructed directly upon the Ayyubid wall.

On the other hand, the wall is located directly below the foundations of the contemporary Jaffa Gate (*Bab al-Khalil*; Figs. 35–37). As the bathhouse was in use until the seventh century CE

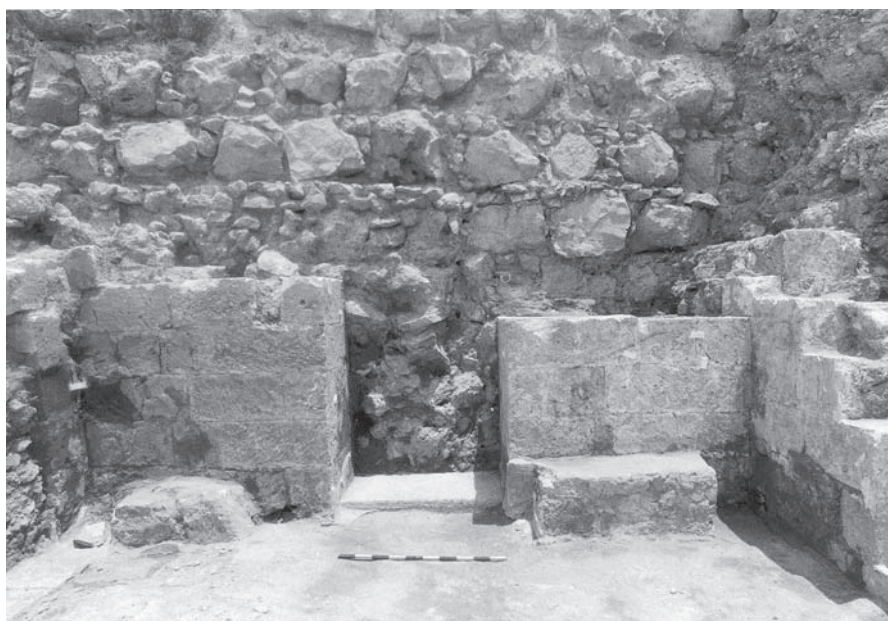
Fig. 37. The Ayyubid wall built into the Byzantine bathhouse, looking east.

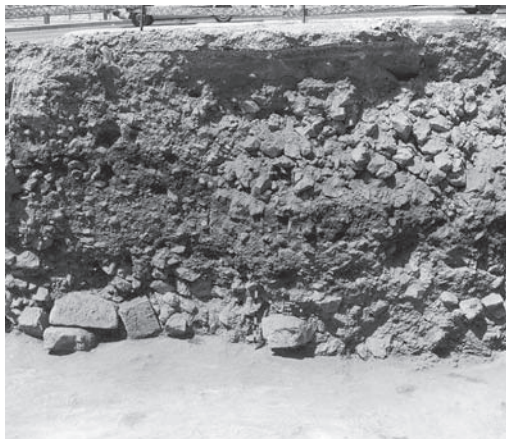
Fig. 38. Section below the modern Jaffa Street, opposite the rock-cut wall; stone collapse covered by black layer, looking south.

0.2–0.4 cm thick. We also encountered this layer closer to the Jaffa Gate (Area A3, which will be published separately). This layer clearly abuts the wall and the tower (Plan1:Sections 1–1, 3–3; Figs. 38, 39).

The black layer, 1.2–2.0 m thick, covers an extremely large and widespread collapse of stones, as well as the rock surface of the

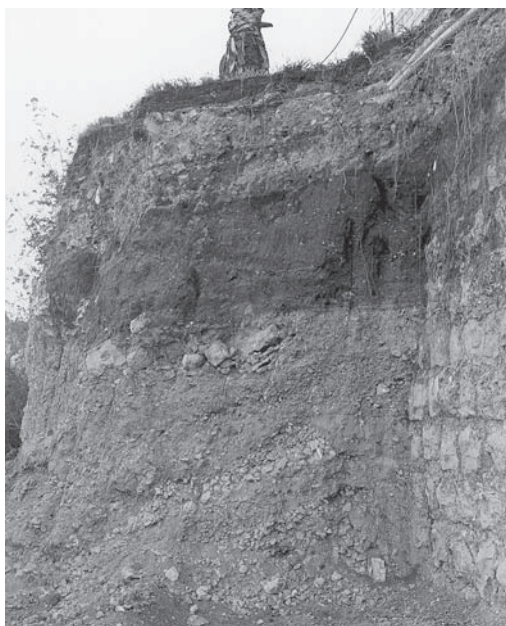
Fig. 39. Section through the debris abutting the Ayyubid wall. The layer of black earth (L202), which is here very thick, abuts the wall and covers the foundation trench (L195), looking northwest.
