SOLOMON'S STABLES, THE TEMPLE MOUNT, JERUSALEM: THE EVENTS CONCERNING THE DESTRUCTION OF ANTIQUITIES 1999–2001¹

JON SELIGMAN

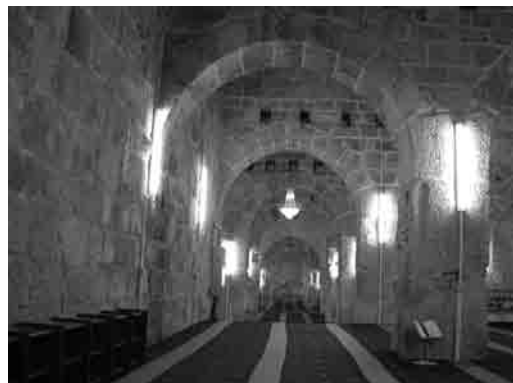
Fig. 1. The interior of Masallah el-Marwani (the new name for Solomon’s Stables) after the renovations begun in 1996.

At this stage, the work did not include major changes to the structure. The archaeological fill was leveled by mechanical machinery and a stone floor was laid by hundreds of volunteers of the Islamic Movement. Electrical cables for lighting fixtures were attached to the ancient columns, causing limited damage to the stonework. Carpets, donated by the King of Morocco, were strewn over the floor (Fig.1).

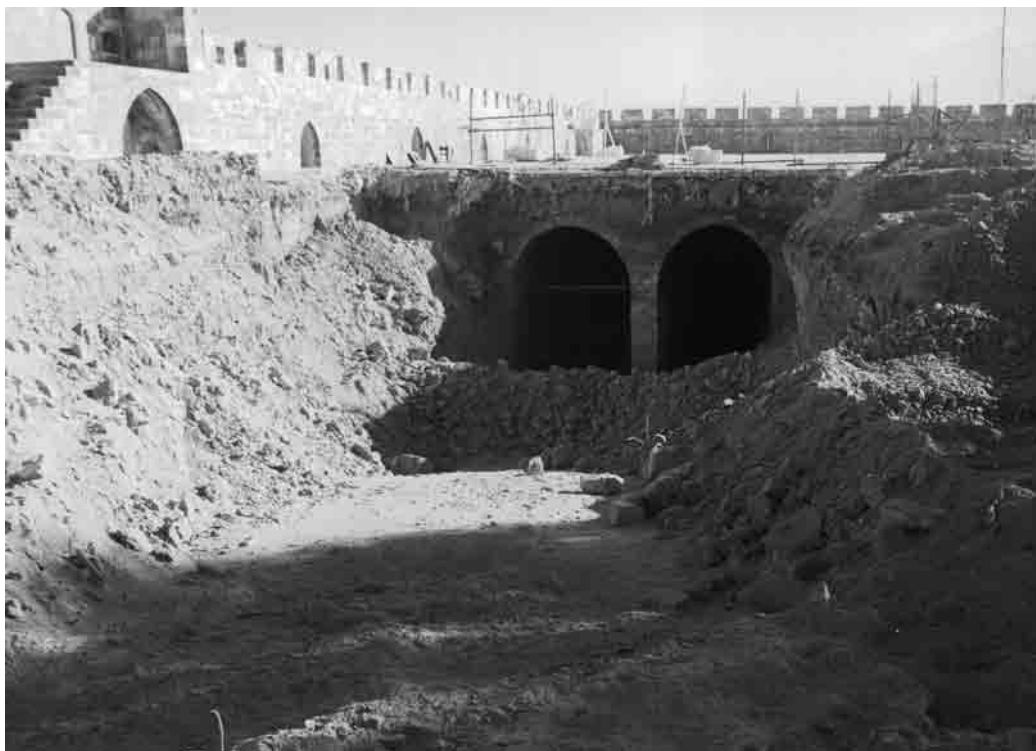
Fig. 2. The pit dug north of Solomon's Stables, November 1999, looking southeast.

By the time the Israeli authorities had grasped the extent of the work and the damage, the Waqf had succeeded in digging out a huge gash, measuring 36 m from north to south and 43 m from east to west (Figs. 2–5). Of the six arches uncovered during the work on the northern wall of the hall, three were completely exposed: two of them were entirely penetrated, the third was partly breached (Plan 3). On the eastern side of the pit an ancient wall (W2; Plan 4) had been

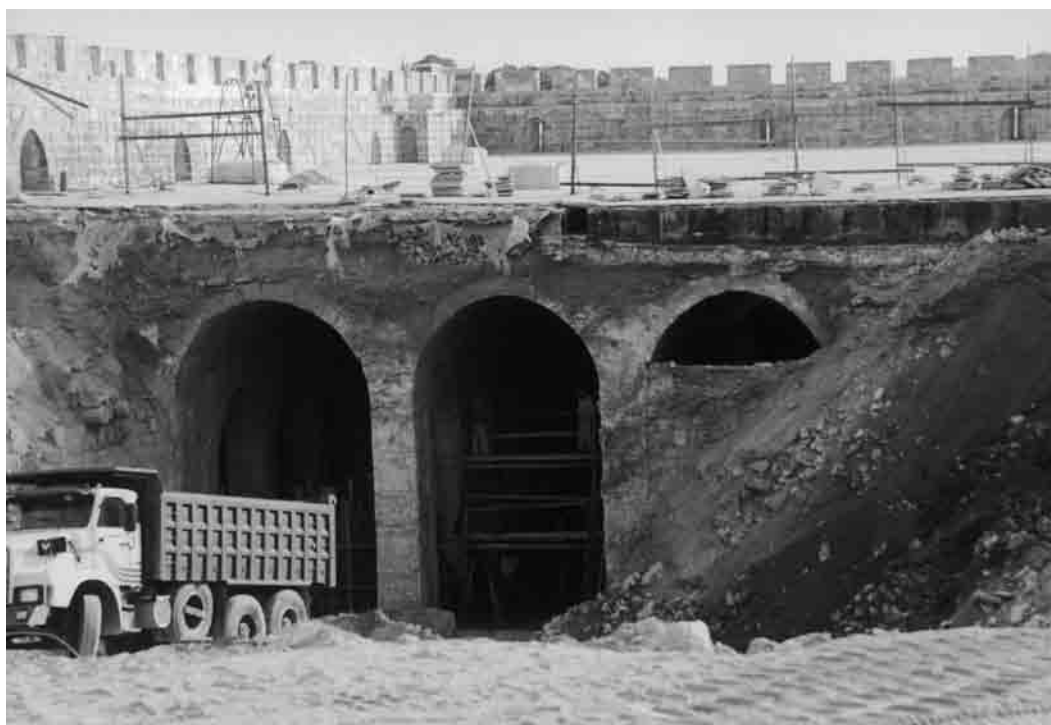
Fig. 3. A truck in front of the newly exposed vaults of Solomon's Stables, November 1999, looking south.

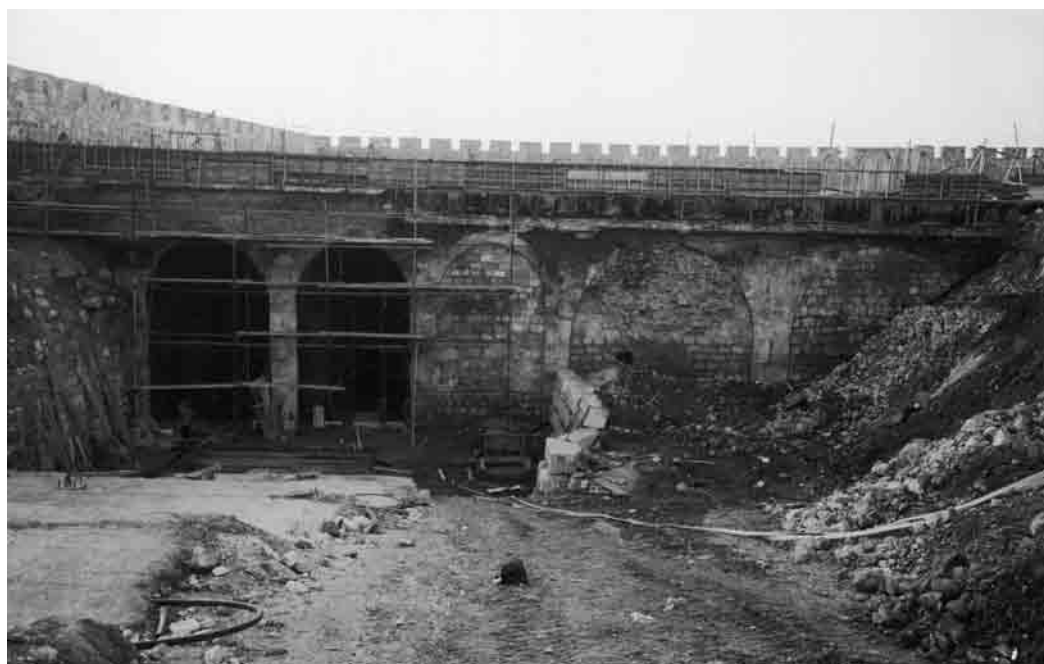
Fig. 4. The exposed northern exterior face of Solomon's Stables, looking south.

This supposition is supported by the broken arch spring on the northern side of the easternmost pier of Solomon's Stables (Plans 3, 4:a; Fig. 6). This pier was built on the same line as Piers 3, 8 and 10, noted above. The northern extent of Solomon's Stables is difficult to assess, yet the traces preserved in the section imply that the vaults stretched at least 27 m north of the present-day standing structure. Alternatively, it is quite possible that these piers stood free and open at the time of their use, in which case the area may be reconstructed as an arcade along the eastern wall of the Ḥaram esh-Sharif, leading to Solomon's Stables. The vaults were entered from the north through seven arches, of which only six are presently visible from the outside (Plan 3; Fig. 4). The easternmost arch would have led directly into the arcade noted above.

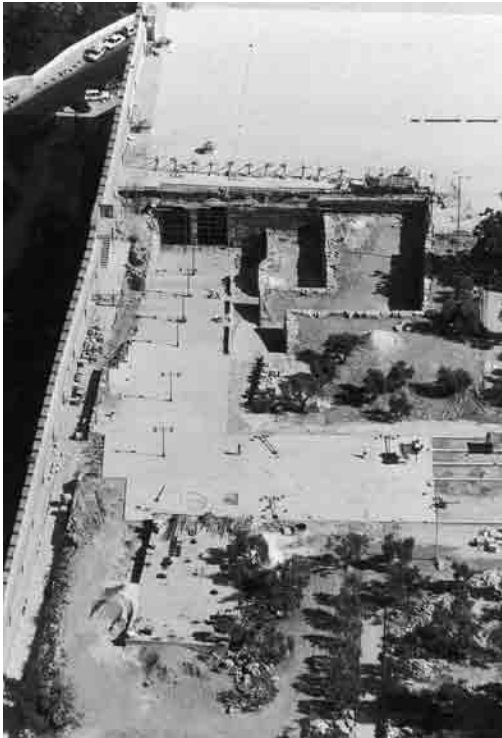
Fig. 5. Aerial view of the construction area north of Solomon's Stables during summer 2000, looking south.

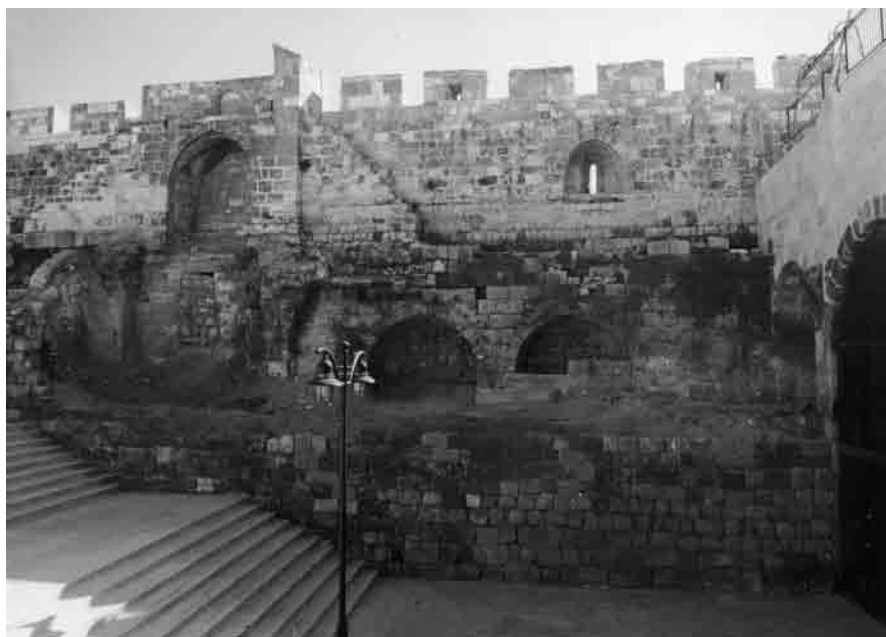
Fig. 6. Southern section of the eastern side of the new staircase, looking east.

Major finds were exposed on the inner face of the eastern wall of the Temple Mount, to the east of the new staircase north of Solomon's Stables (Plan 4; Figs. 6–9). The lower externally exposed sections of this part of the wall are clearly dated to the Second Temple period, either from Hasmonean or Herodian times (Burgoyne 2000:482–483).

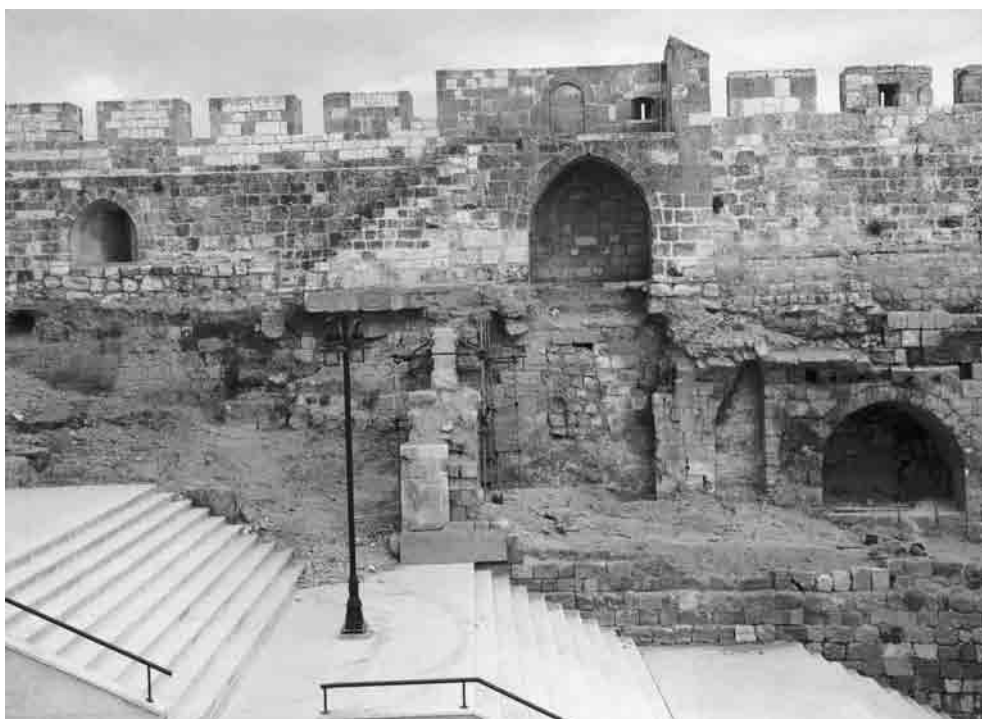
Fig. 7. Northern section of the eastern side of the new staircase, looking east.

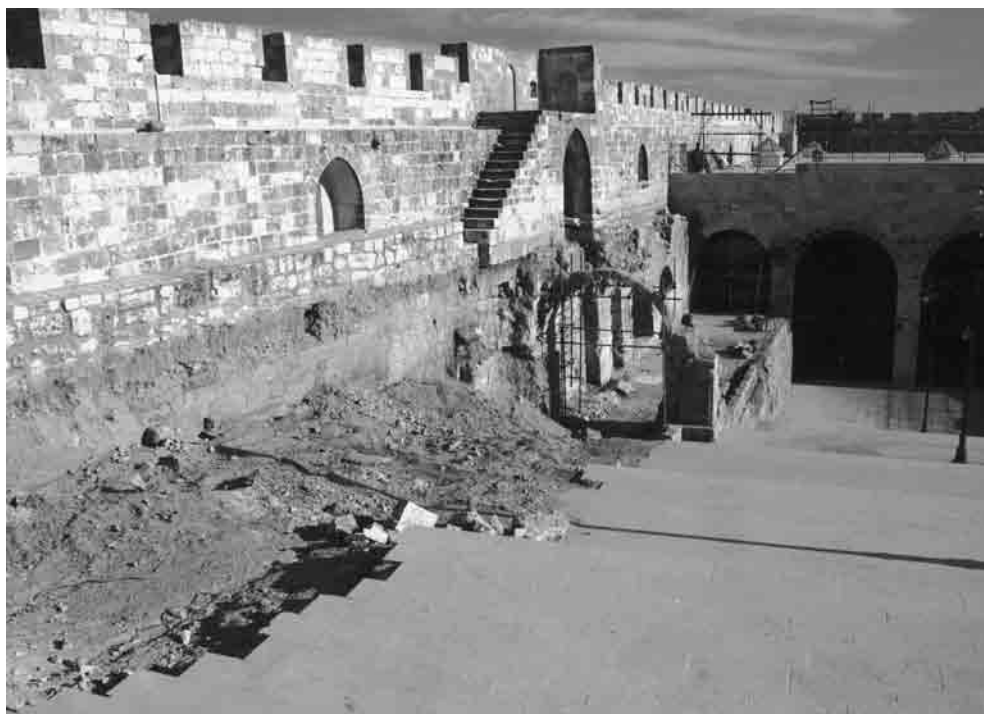
Fig. 8. View of the new staircase into Solomon's Stables and the various walls on the eastern side, looking southeast.

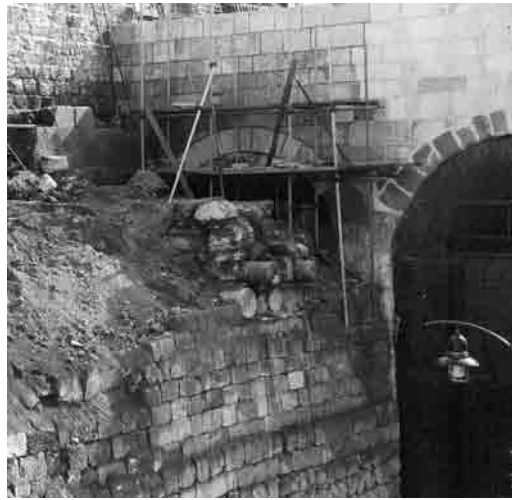
Fig. 9. Wall 2 with columns in secondary use laid within, before removal.

The third stage of building includes a roughly built wall (W2; Plan 4), set between the easternmost pier of W4 and P3 of Stage I, abutting the latter. The upper courses of W2 were severely damaged by the construction work in November 1999 and additional sections were lost in January 2001. It is 19.5 m long and is parallel to the eastern wall of the Temple Mount, at a distance of 5.5 m to the west. Wall 2 is built of ashlar blocks, mostly similar
